ENTERPRISE CAPE BRETON CORPORATION FORMER MINE SITE CLOSURE PROGRAM

Update 2013-2014

Enterprise Cape Breton Corporation Former Mine Site Closure Program Update September 2013

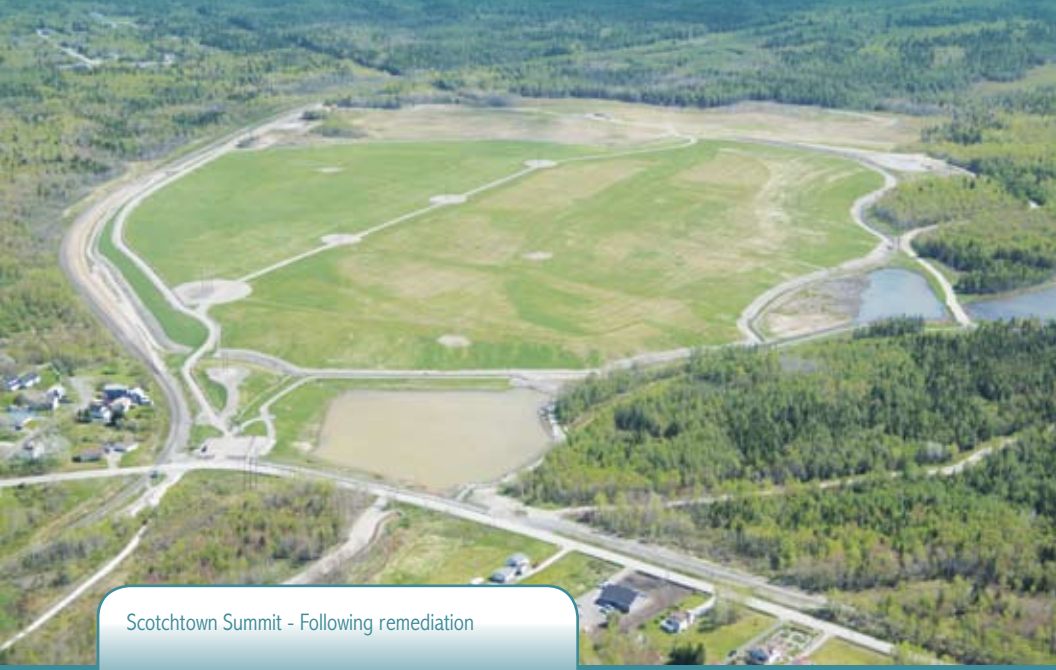
Scotchtown Summit - Following remediation

In autumn 2010, a contract was awarded to start the grading and capping of the waste rock pile, as well as installation of perimeter ditches and site access features. The cap

system included a layer of bedding sand, a high density polyethylene liner, a protective layer of geotextile, followed by a half metre of cover soil and finally hydro-seeding. As the liner and geotextile was placed on the pile, a second contractor was working on an adjacent site to produce the cover soil for the capping contract. Through the use of on-site borrow material as the source of the cover soil, impact to the local community was drastically reduced by avoiding the truck traffic required to import the cover soil.

The final component of the remediation activities was completed at the site in March 2012 and included the installation of a recreational trail network and minor site improvements to the north of Daley Road. The trail network provides a combination of pedestrian and bicycle paths in addition to all terrain vehicle (ATV) routes around the site that connect to existing ATV trails off-site.

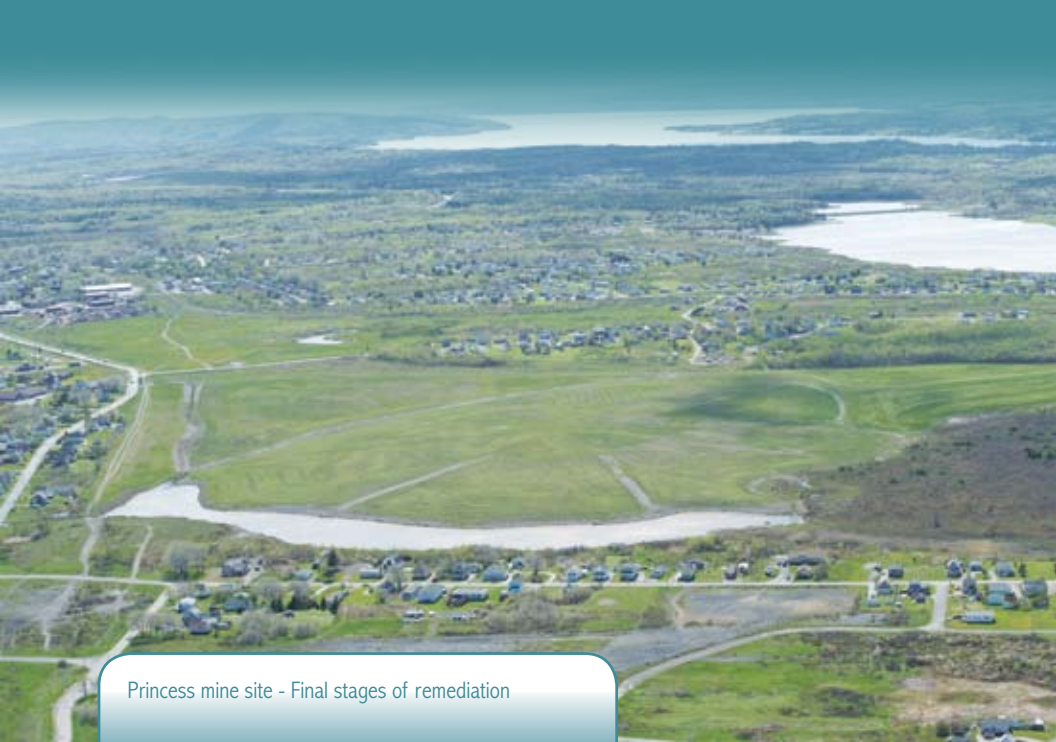
Princess mine site - Final stages of remediation

Remediation of the coarse waste rock pile is now complete and involved site grading and reshaping, as well as the installation of a high-density polyethylene liner, a protective layer of geotextile, and a soil cover cap. The site was hydro-seeded and vegetation established. A Site Management Plan (SMP) including an EMTA is currently in place. The SMP developed for the Princess colliery site outlines the long-term environmental, geotechnical and landscape monitoring and inspection requirements as well as appropriate corrective actions should issues be identified.

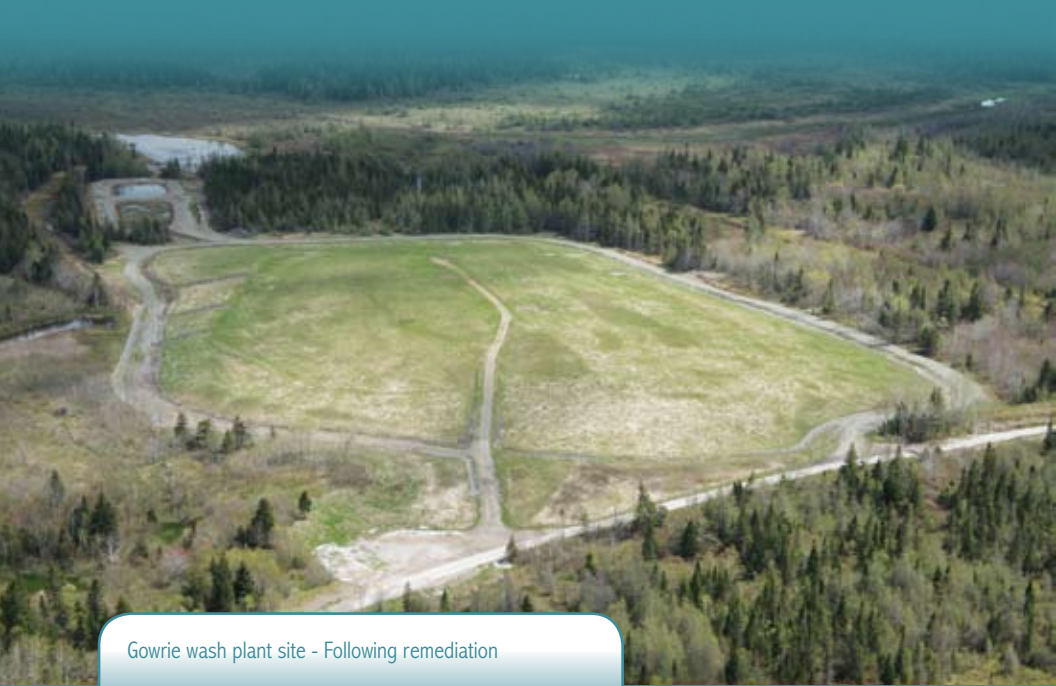
Gowrie wash plant site - Following remediation

The remediated Gowrie wash plant site consists of a large waste rock pile and two construction settling ponds that have since been converted to discharge tailings ponds to manage the quality of drainage water reporting to an adjacent wetland. Construction activity on the site is now complete and involved grading, reshaping, installing a high-density polyethylene liner, capping with a soil cover, and hydro-seeding. Vegetation has been established. A Site Management Plan (SMP) including an EMTA is currently in place. The SMP developed for the Gowrie site outlines the long-term environmental, geotechnical and landscape monitoring and inspection requirements as well as appropriate corrective actions should issues be identified.

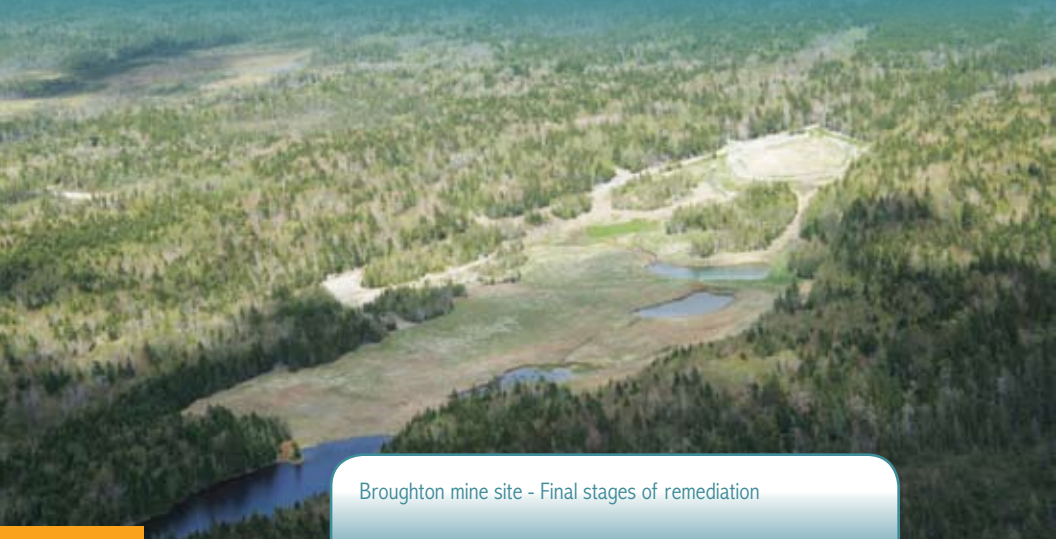
Broughton mine site - Final stages of remediation

Construction activity at the former Broughton colliery mine site has been completed. A high density polyethylene liner has been installed over the remaining waste pile on site and vegetation has been established. A Site Management Plan (SMP) is currently in place and PWGSC is working with a consultant to finalize the EMTA by March 2014. The SMP developed for the Broughton site outlines the long-term environmental, geotechnical and landscape monitoring and inspection requirements as well as appropriate corrective actions should issues be identified.

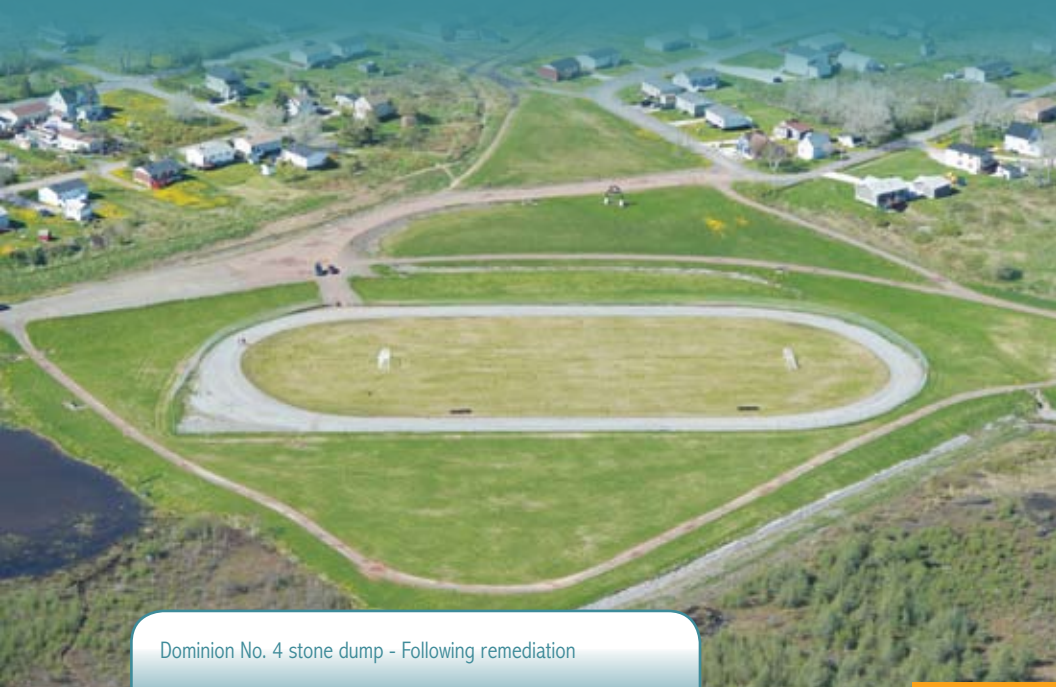
Dominion No. 4 stone dump - Following remediation

The Dominion No. 4 stone dump is situated directly next to a residential area in south Glace Bay. The site went through a phased assessment process to identify issues of concern, followed by a comprehensive planning and design cycle to develop the optimum remediation strategy to ensure maximum benefit for the surrounding community. ECBC worked with CBRM to develop a recreational land use plan for the site. Design and construction of a low permeability clay cover, an eight lane track, a soccer pitch, and walking trails have been completed. Some upgrades to drainage and vegetation were completed in the summer of 2011. A Site Management Plan (SMP) including an EMTA is currently in place. The SMP developed for the Dominion No. 4 site outlines the long-term environmental, geotechnical and landscape monitoring and inspection requirements as well as appropriate corrective actions should issues be identified.

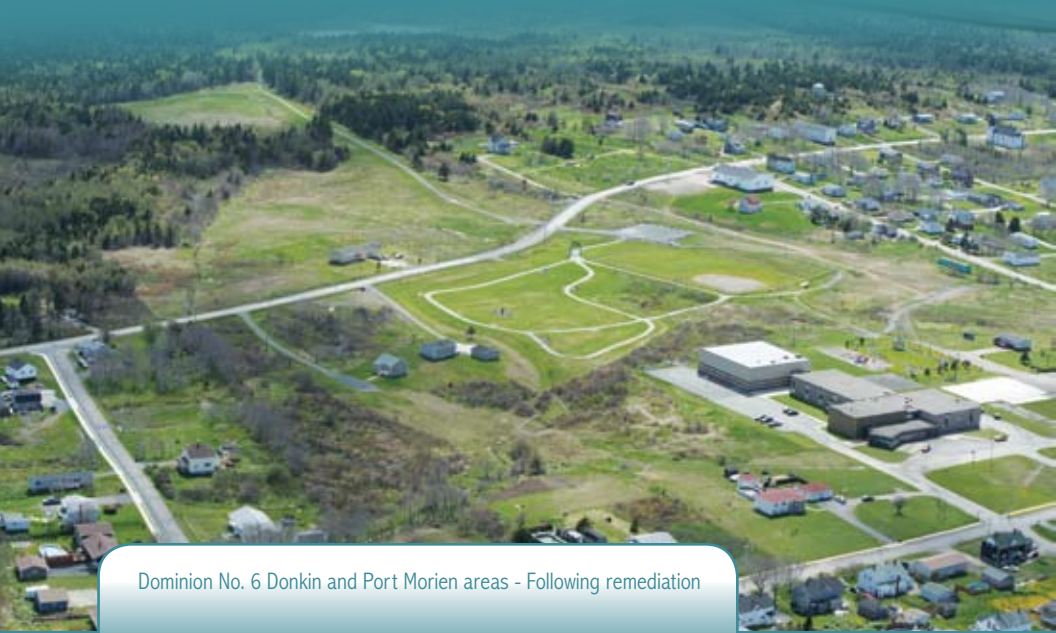
Dominion No. 6 Donkin and Port Morien areas - Following remediation

Remediation activities completed at the Dominion No.6 site included consolidation of waste rock material, grading and improving surface drainage, installing soil cover, installation of walking trails, and hydro-seeding. Remaining construction activities to be completed this year include work required to address the subsidence associated with former mine workings/openings. A Site Management Plan (SMP) is currently in place. The SMP developed for the Dominion No.6 site outlines the long-term, geotechnical and landscape monitoring and inspection requirements as well as appropriate corrective actions should issues be identified.

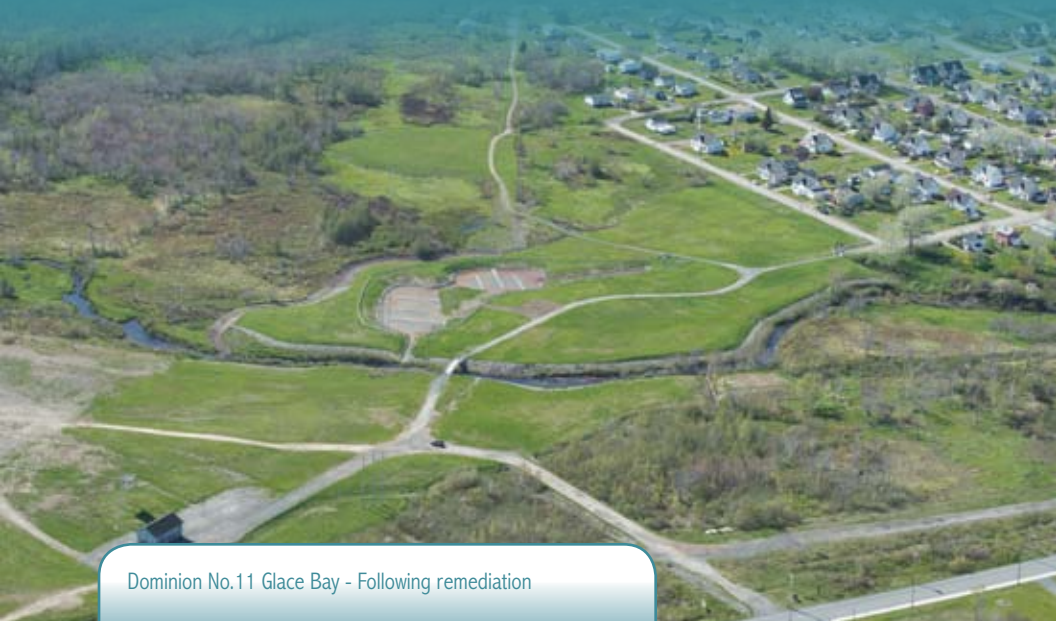
Dominion No.11 Glace Bay - Following remediation

The former Dominion No. 11 mine site is located in south eastern Glace Bay, west of Brookside Street. The old surface infrastructure that used to support sub-surface coal mining has been removed. Environmental impacts included acid waste rock, subsequent acid water drainage, mine water discharge, hydrocarbon-contaminated soil, as well as health and safety related issues associated with mine workings. As part of the cleanup activities, the hydrocarbon impacted material has been removed, passive treatment ponds have been installed to treat the mine water outflows, the site has been graded, necessary surface drainage features installed, and soil cover and hydro-seeding requirements have been completed. A new bridge crossing has been installed over Renwick Brook.

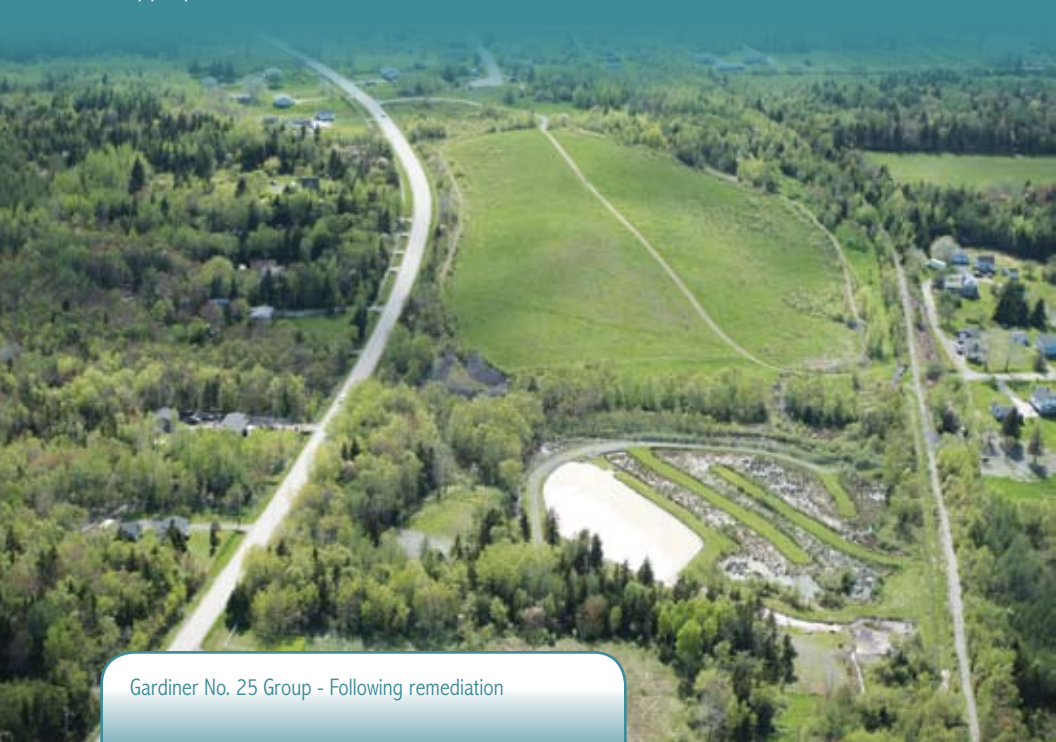
Gardiner No. 25 Group - Following remediation

the main site, including the installation of mine water control wells, the installation of a wetland treatment system and covering of the coarse waste rock pile. Remediation work on the waste rock pile is complete, including consolidation of waste rock around the perimeter of the existing pile, installation of a simple soil cover in barren areas, relaxing the grade of steep slopes, hydro-seeding, and installation of physical security barriers. The Site Management Plan developed for the former Gardiner No. 25 mine site outlines the environmental, geotechnical and landscape inspection requirements, as well as appropriate corrective actions should issues be identified.

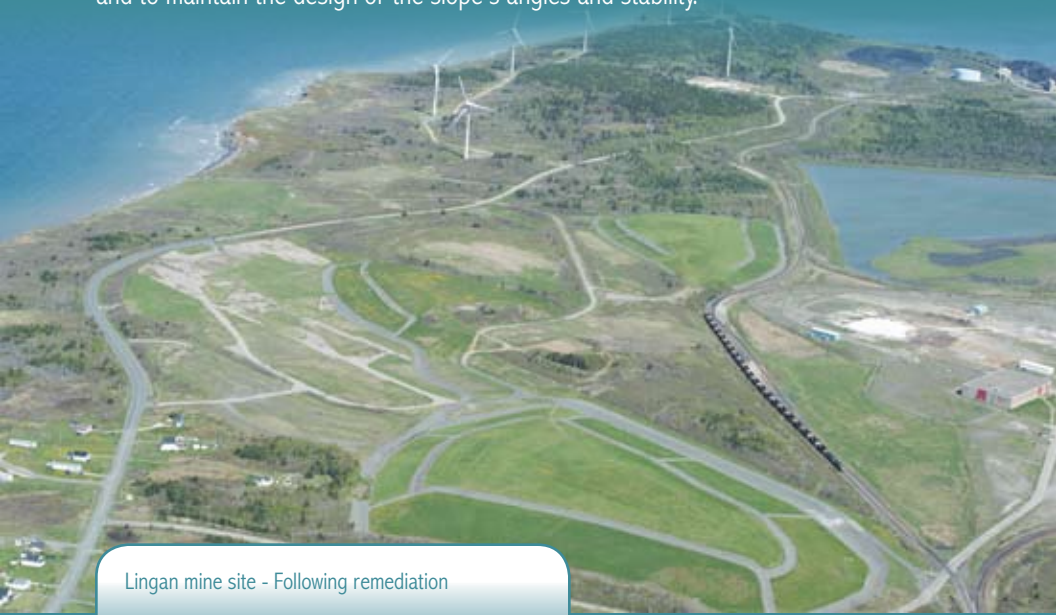
Lingan mine site - Following remediation

The clean-up at the former Lingan colliery site is now complete. Three waste rock

piles have been graded and a soil cover was applied and hydro-seeded. Perimeter and drainage ditches were installed at each site to help manage rainwater and prevent soil cover erosion. Toe protection was installed at the base of the rock piles for long-term protection and stability - toe protection is the strategic placement of rock or other “ballast” to act as a mass to help hold back the toe of the slope, to help prevent erosion, and to maintain the design of the slope’s angles and stability.

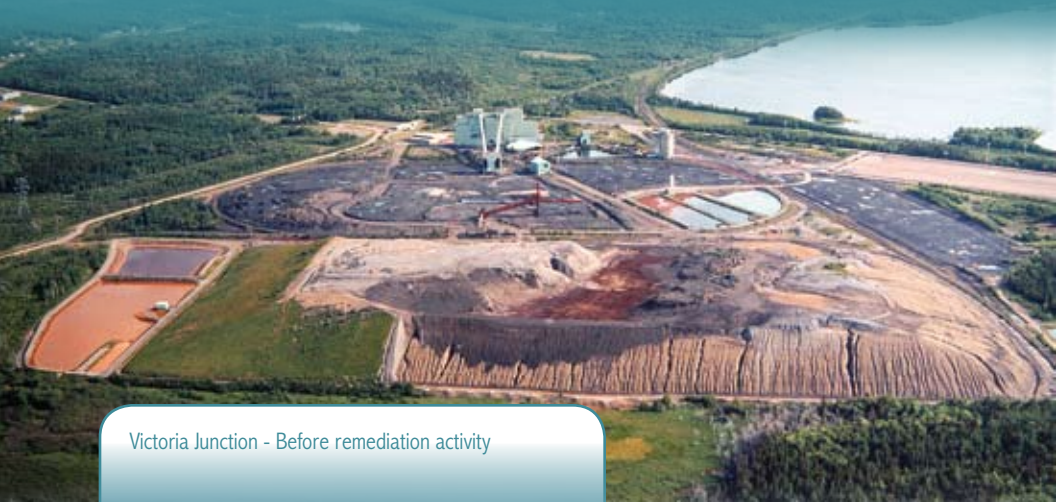
Victoria Junction - Before remediation activity

The Victoria Junction group of properties consists of 11 sites including the Victoria Junction coal preparation plant and the tailings basin. Closure works at the Victoria Junction coal preparation plant are complete. The tailings basin encompasses the tailings pond dam, the downstream settling pond and associated infrastructure. The dam has been in a state of monitoring and maintenance since its operations ceased in the 1990s. Work activities associated with the tailings basin included the implementation of required upgrades to infrastructure to ensure continued safety and longevity of the structure. The Dam Safety Review and Emergency Preparedness Plan have been updated to reflect the alterations to the tailings pond dam.

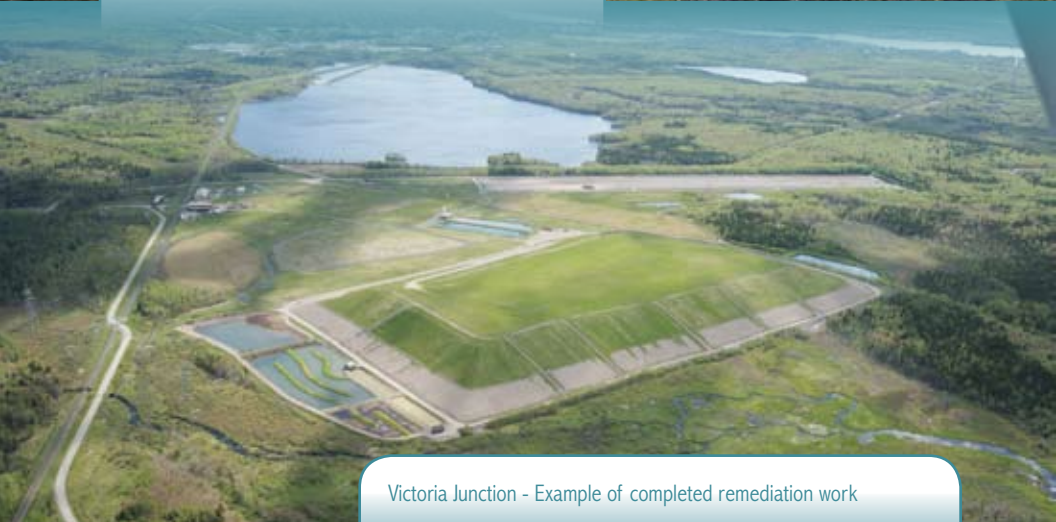
Victoria Junction - Example of completed remediation work

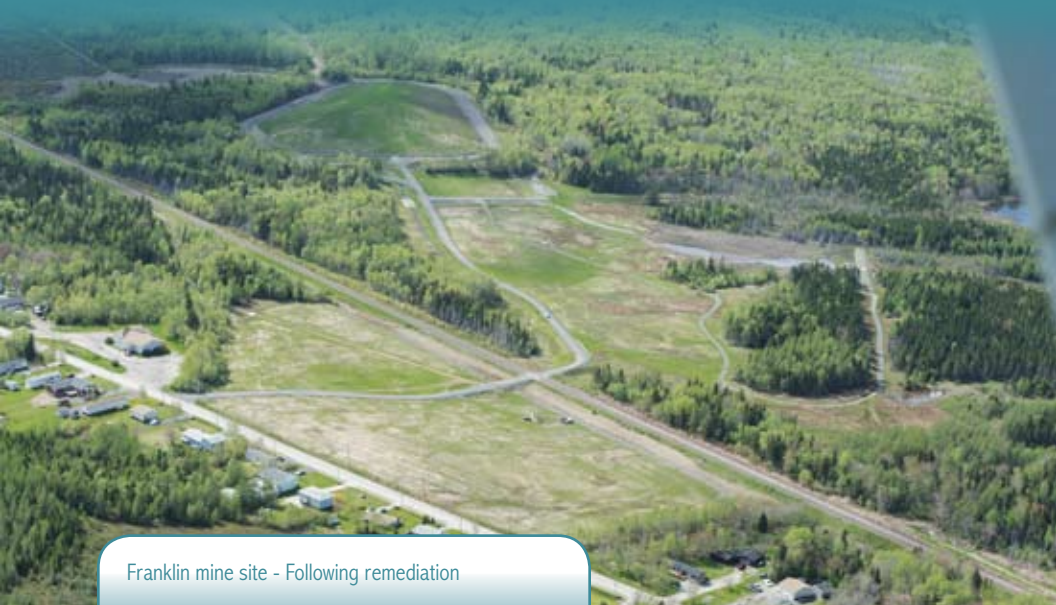
Franklin mine site - Following remediation

Remediation of the six sites and their related properties is complete. Remediation involved removing surface mine structures and related debris, consolidating waste rock

material to the former Franklin mine site, and dealing with soil erosion. Construction activity included grading and reshaping the waste rock pile, installing a high-density polyethylene liner, capping the pile with a soil cover, and hydro-seeding. Vegetation has been established on all of the six sites. Additionally, the Franklin site is the location for the passive treatment system to deal with water outflow from the Prospect No. 5 mine site. This system, along with the cleanup efforts on the Franklin site, has improved water quality in the adjacent Sullivan's Pond to a point where the aquatic life is returning. The treatment system continues to address the Prospect No. 5 outfall with no maintenance performed to date.

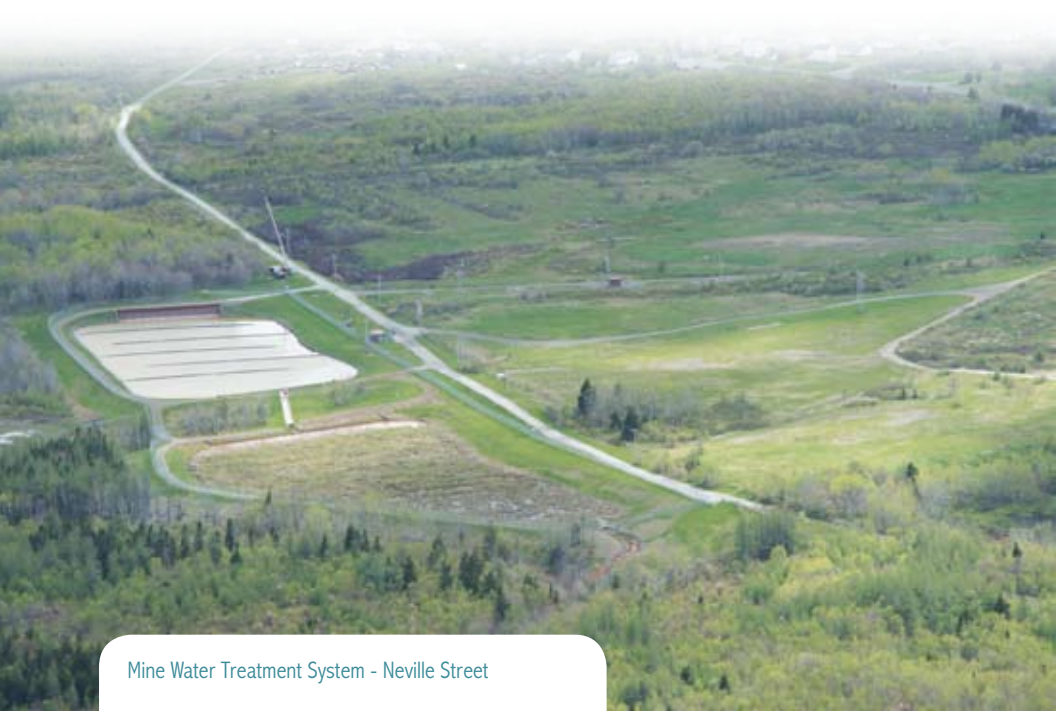
Mine Water Treatment System - Neville Street

In late 2007, ECBC began implementation of a formal Mine Water Management Program (MWMP) that included the construction of a 300 litre per second capacity passive treatment system in the community of Reserve Mines. This treatment system was designed to deal with the combined mine water discharges from the 1B mine pool.

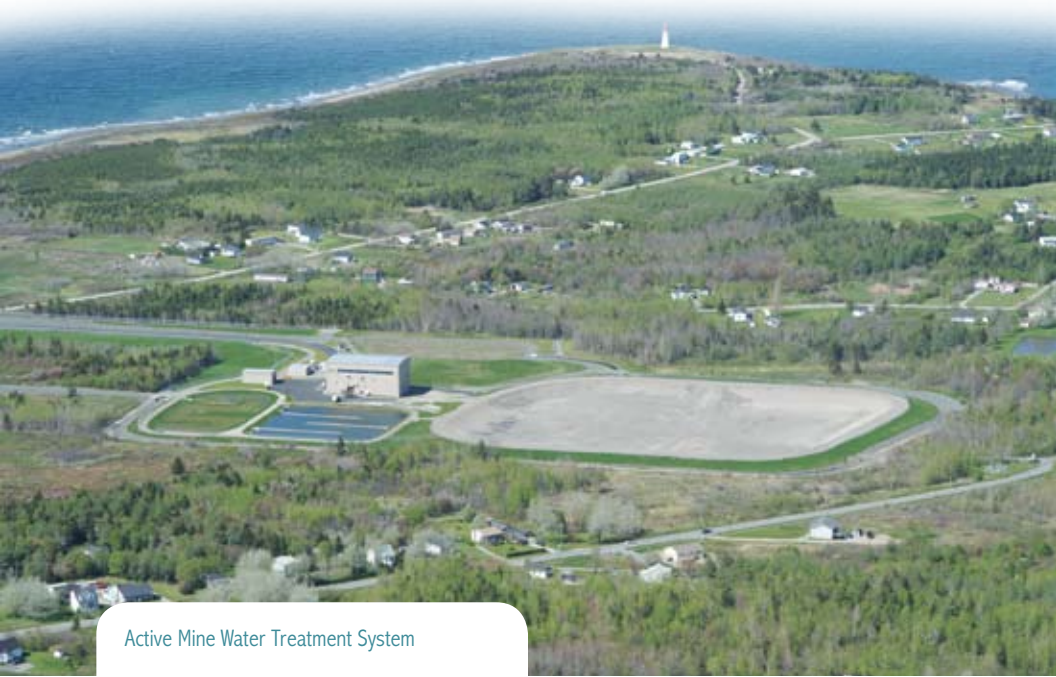
Active Mine Water Treatment System

The location for the treatment plant and the final design process was settled in August 2010 after it was determined that one plant located in New Victoria could treat the mine water from the combined New Waterford and Sydney Mines mine pools. This decision

A public open house to view the details and comment on the project was held at the New Victoria fire hall on January 19, 2011. Site clearing and preparation of civil structures began in March 2011. The actual construction of the Treatment Plant and ancillary buildings began in November 2011, and were substantially completed by September 2012. Commissioning of the Treatment Plant equipment began in October 2012, and the actual treatment of mine water from the flooded New Waterford Mine Pool began in earnest in January 2013. To date, more than 6 million gallons of contaminated mine water have been successfully treated. It is forecast that the rising mine waters from the Sydney Mines mine pool will be collected and treated in the same plant by early 2014.
